ROCHESTER GROUND WATER QUALITY INVESTIGATION

by
Denis Erickson

Washington State Department of Ecology
Environmental Investigations and Laboratory Services Program
Toxics Investigations/Ground Water Monitoring Section
Olympia, Washington 98504-8711

November 1990

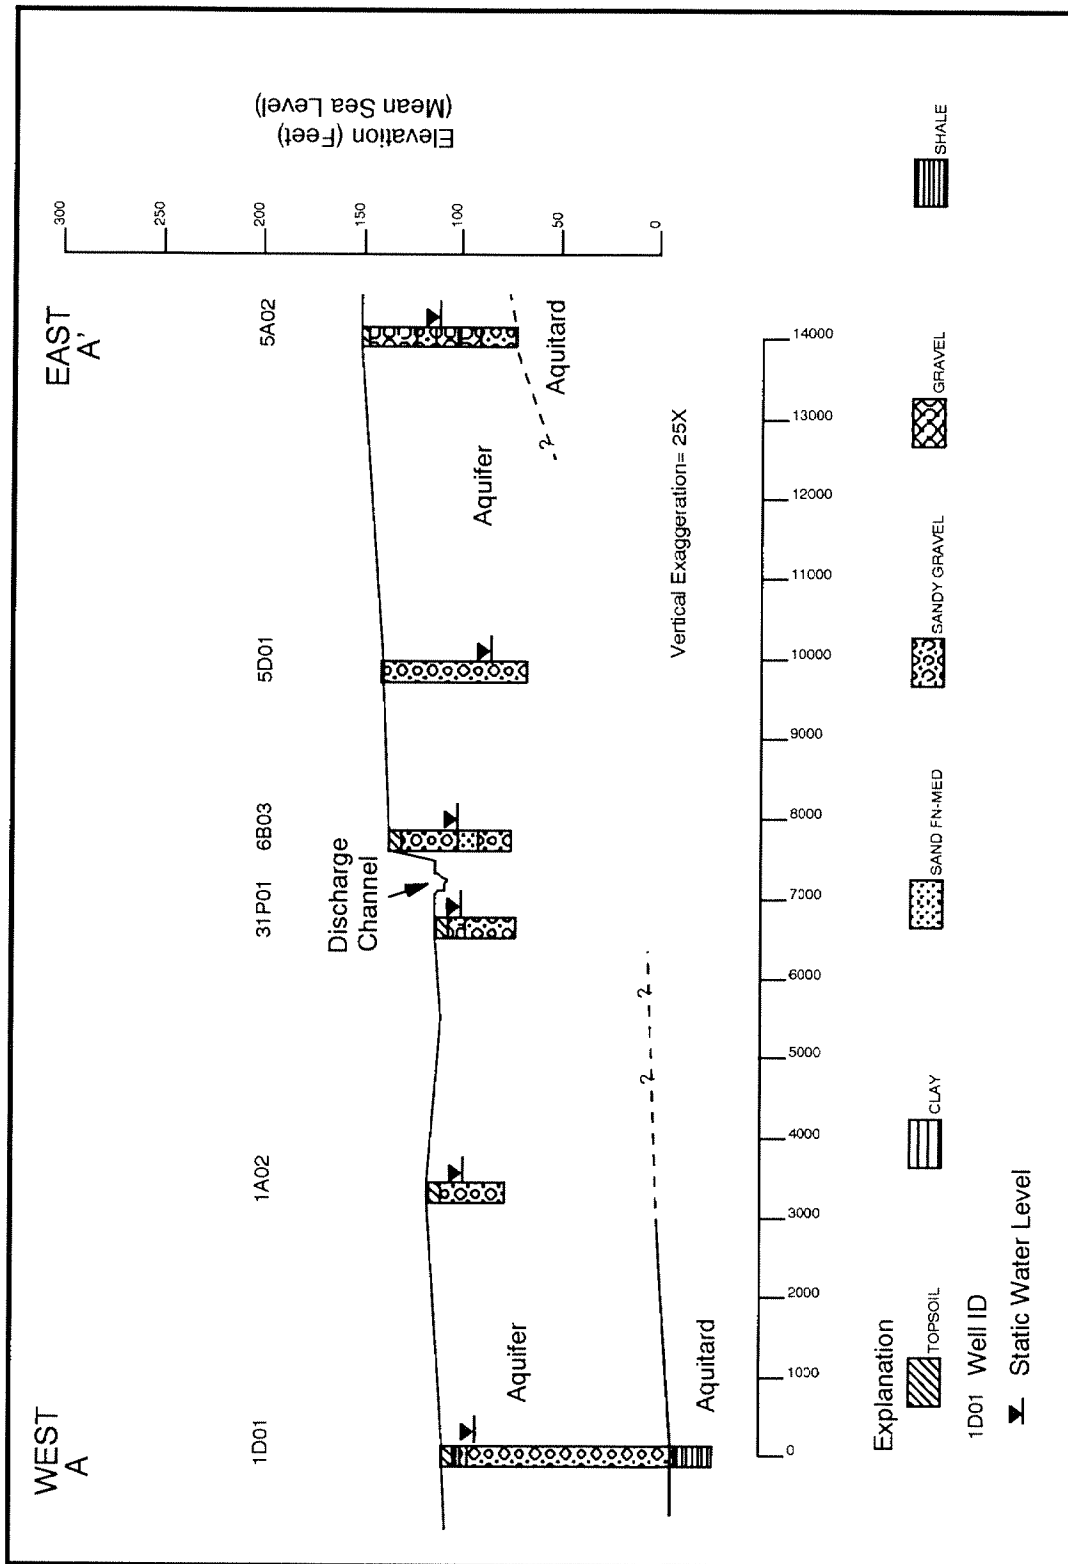
Figure 2: Hydrogeologic Profile A-A'

The study area is underlain by glacial outwash and alluvial sediments (Wallace and Molenaar, 1961). A west-east hydrogeologic profile (Figure 2) shows the subsurface relationship of the unconsolidated deposits to the discharge channel and selected wells. The glacial outwash is continuous beneath the study area and consists of unconsolidated sand and gravel deposits. Alluvial deposits overlie the outwash deposits on the west side of the study area and consist of mixtures of clay, silt, sand, and gravel. The alluvial sediments are floodplain deposits of the modern Chehalis and Black Rivers. The study area surficial soils consist of loamy sand and gravelly sandy loam east of the Steelhammer facility and silty clay loam west of the facility. The sandier soils are associated with the outwash deposits and the silty clay loam soils are associated with the alluvium and modern floodplain. The discharge channel appears to have been underlain in most locations by silty clay loam (Ness, 1958). Sedimentary bedrock crops out in the low hill on the east side of the study area. Because of the low permeability of the bedrock relative to the outwash and alluvial sediments, it is considered a no-flow boundary for this assessment.

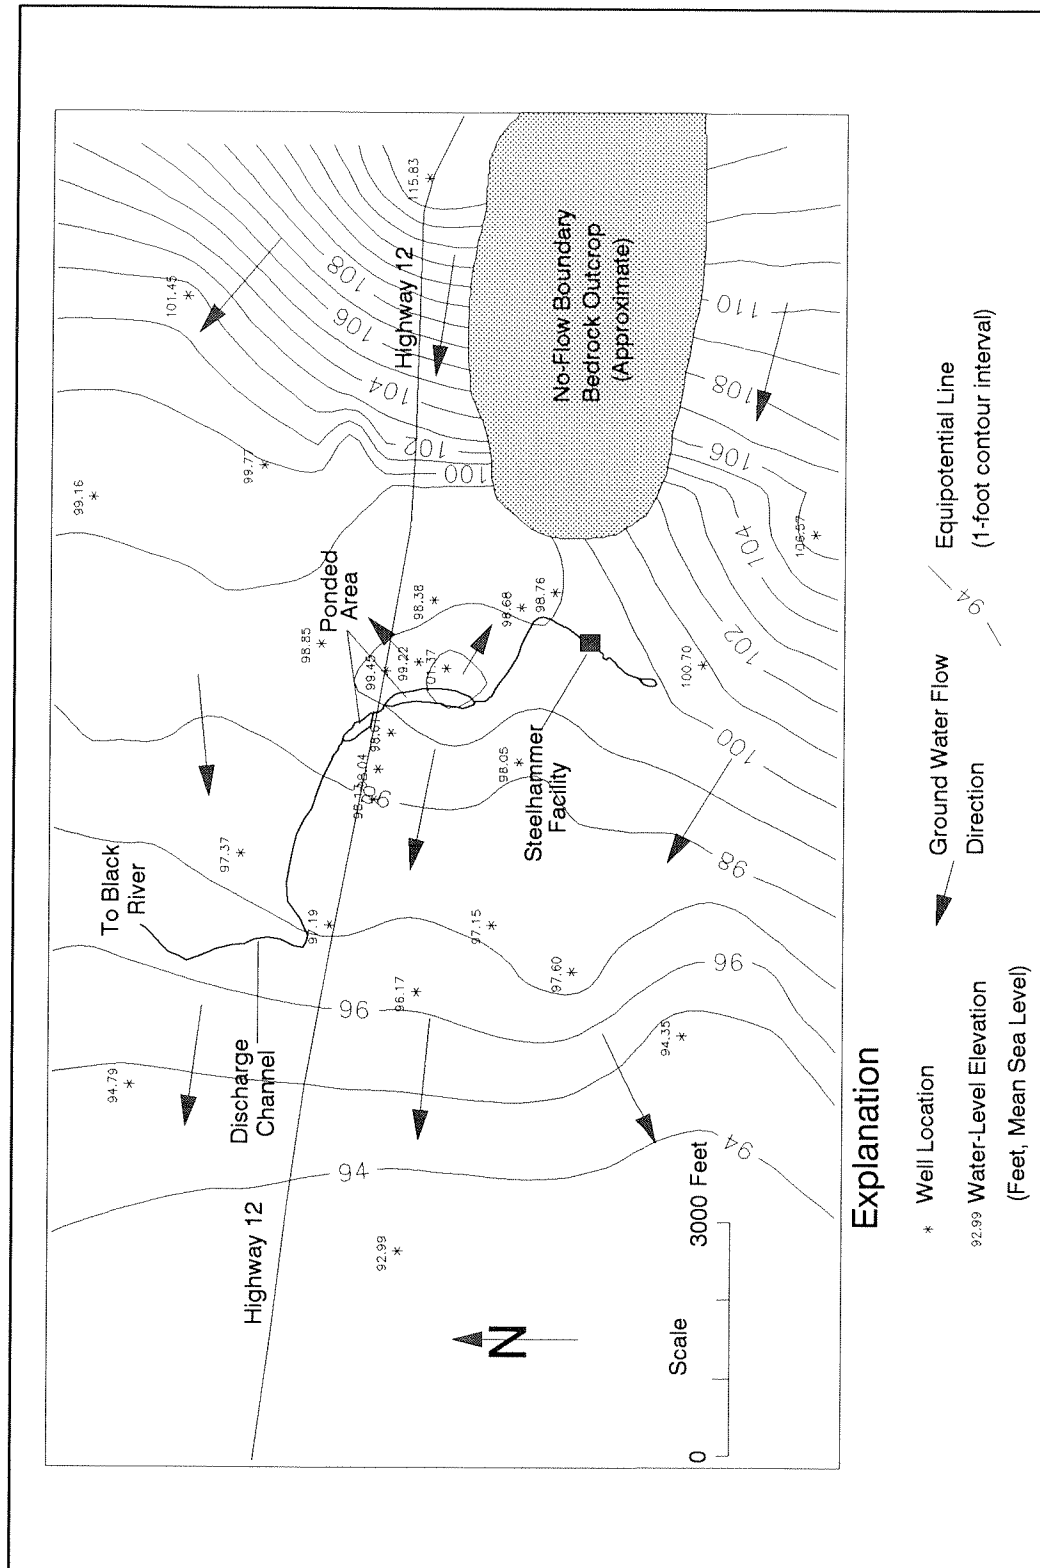
Figure 3: Water-Table Contour Map, October 1989

The water level in the discharge channel as determined at the three surface water stations is about ten feet above the water table. Therefore the channel provides a downward driving force for water and dissolved contaminants. The water table contour map (Figure 3) shows a distortion of the equipotential lines, in particular the 99- and 100-foot contours, in the vicinity of the ponded area of the channel near Highway 12. Leakage from the channel is likely occurring which results in localized mounding of the water table. It appears that the leakage rate from the channel is enough to cause mounding, but it would also suggest that there may not be a direct hydraulic connection (i.e. the entire thickness of sediments underlying the channel may not be saturated). The water table is mounded about two feet at one well (06B02) about 200 feet from the channel. Unfortunately, the amount of mounding and the degree of hydraulic connection with the channel and the water table can only be estimated with the existing data.

Based on the ground water flow direction shown in Figure 3, only one well, the trailer court water supply well (06H04), is located downgradient of part of the trailer court. Unfortunately the trailer court is also downgradient of the ponded area near Highway 12 and, therefore, may not be a good measure of potential loading from septic tanks. The nitrate+nitrite as N (3.7 mg/L), chloride (6.1 mg/L), and total dissolved solid (150 mg/L) concentrations, parameters associated with septic tank effluent, are slightly elevated above background concentrations. However, these slight elevations do not, at present, represent a significant threat to ground water quality.

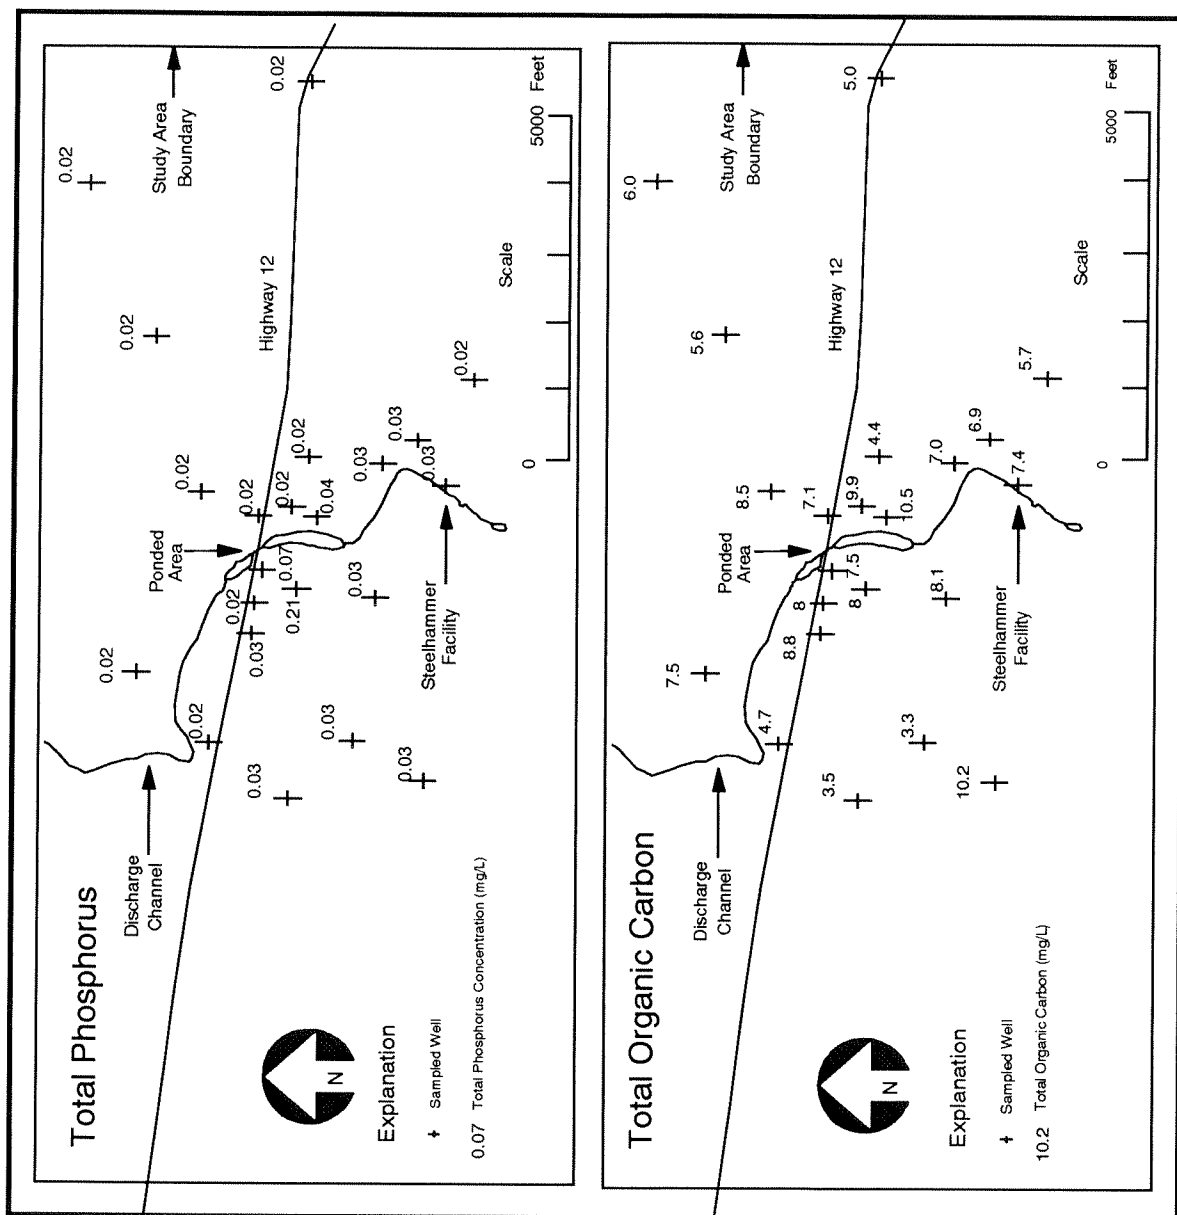
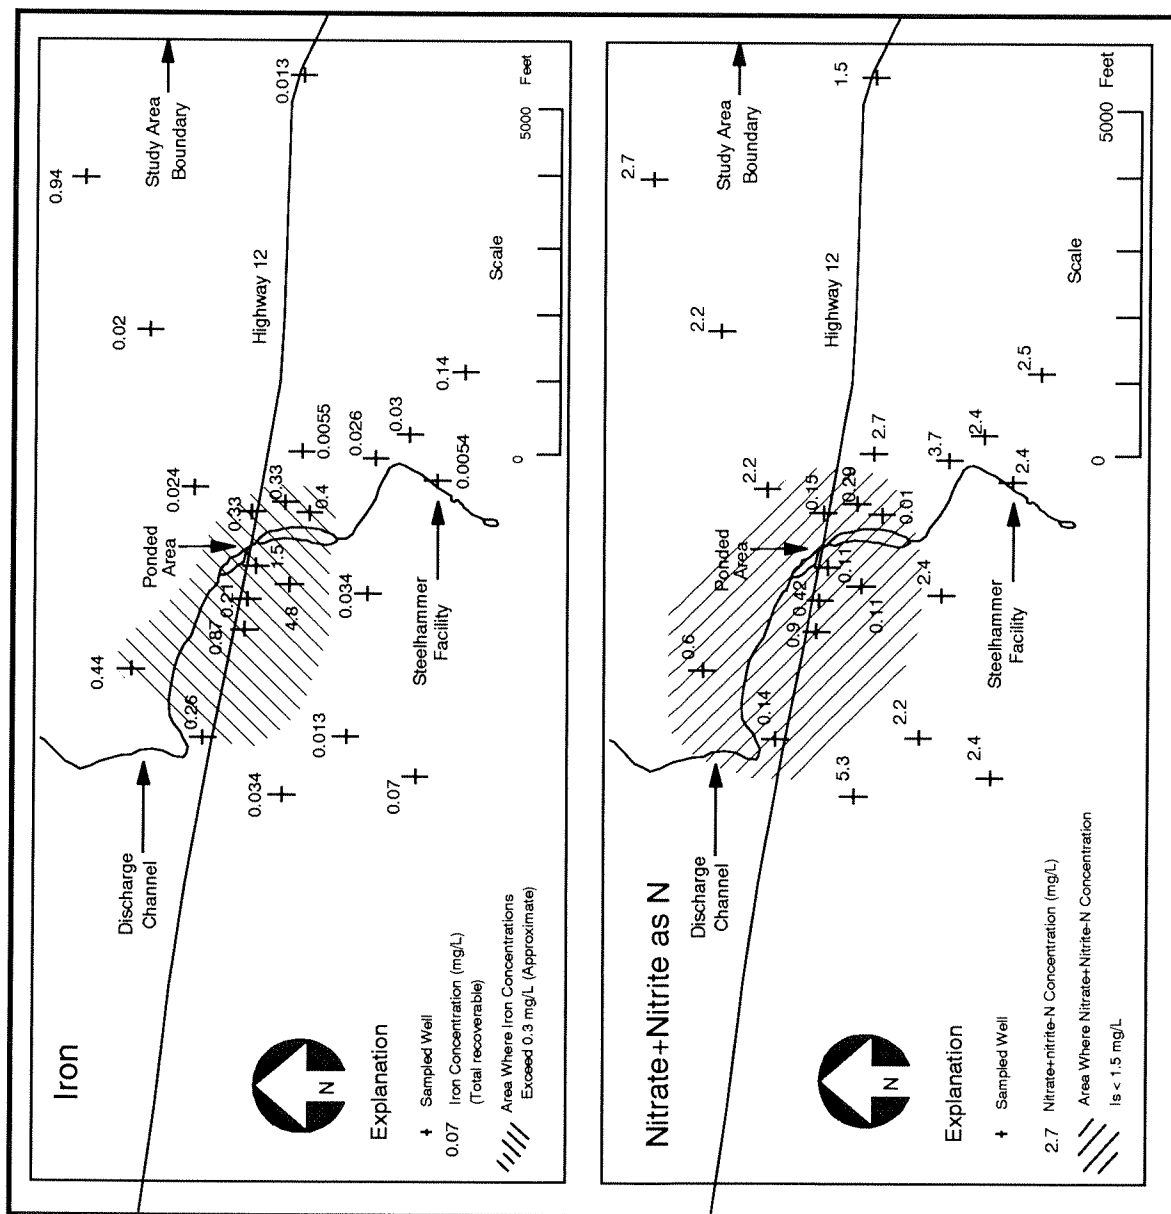
Figure 5. Iron and Nitrate-Nitrite as N Concentrations (mg/L)

Two other parameters, iron (total recoverable) and nitrate-nitrite as N, have concentration distributions (Figure 5) that appear to be affected by the discharge channel and are discussed below. Iron was present in the effluent and the discharge channel at concentrations of about 0.01 to 0.05 mg/L. Upgradient concentrations of iron generally ranged from 0.01 to 0.02 mg/L with the exception of one upgradient well, 32G03, which showed a concentration of 0.94 mg/L. Seven wells in the vicinity of the ponded area near Highway 12 showed substantially elevated concentrations of iron that ranged from 0.2 to 4.7 mg/L.

Nitrate-nitrite as N distribution shows a different pattern. Nitrate-nitrite as N was present in the effluent at 0.68 mg/L and in the discharge channel at concentrations ranging from less than the detection limit, 0.01 mg/L, to 0.81 mg/L. The concentration in the discharge channel decreased

downstream of the facility. Nitrate-nitrite as N concentrations in wells ranged from less than the detection limit (0.01 mg/L) to 5.3 mg/L. Upgradient concentrations ranged from 2 to 3 mg/L. Concentrations less than 1 mg/L occurred in the area immediately downgradient of the ponded area near Highway 12. The maximum concentration, 5.3 mg/L, occurred at a well (01A02) at the far west side of the study area.

3. Iron exceeded the secondary MCL, 0.3 mg/L, in eight of the wells tested. The concentrations in the eight wells ranged from 0.33 to 4.77 mg/L. Six of these wells are near the ponded area near Highway 12. The mobilization of iron is due to the reducing and probably acidic conditions that exist beneath the discharge channel.
